Evaluation of Tree Planting Practices in The Urban Landscape

*James R. Urban
Urban and Associates
Annapolis, Maryland*

Proceedings of the Fourth Urban Forestry Conference

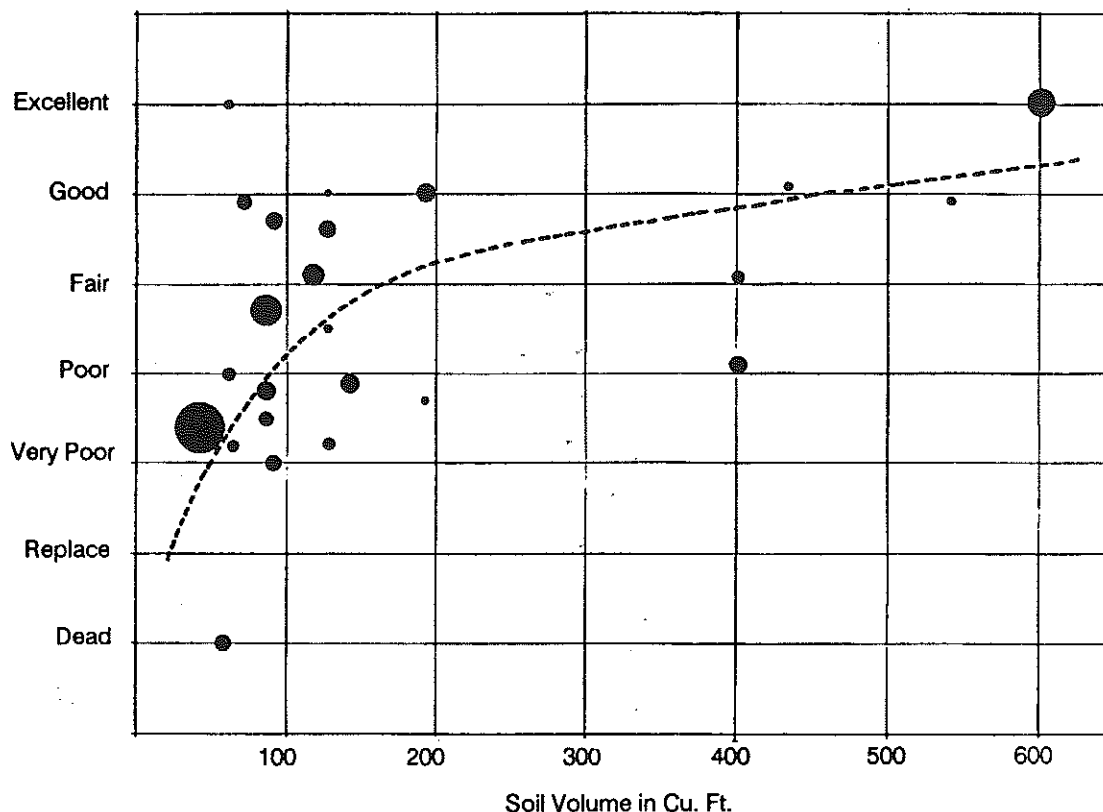
Figure 1. Tree Condition--Soil Volume

Current Average Tree Condition Compared to Soil Volume. The condition of each tree was ranked using a numerical system (1 to 7) to allow graphic comparison to other factors (figure 1). When compared to soil volume, there is a continuous increase in overall tree performance as soil volume increases. This increase is dramatic at lower soil volumes (40 to 100 cubic feet) and flattens above about 150 cubic feet. This flattening can be explained by the following theories: (1) The trees with larger soil volumes are younger and have not filled the area provided; (2) Given the wide range of species in the study, different species

are reacting differently to soil volume and other site factors; and (3) Other urban stresses may account for a large portion of exhibited tree condition.

One tree group shows an average condition which seems to be inconsistent with other data results; the red oaks of the Christian Science Project are in one of the smallest soil volumes yet scored an average of "excellent." This site has three important factors that contribute to its success: (1) The surrounding sidewalk has subsided, indicating poor compaction in the area; (2) The project site has good drainage; and (3) there is a large irrigated lawn area adjacent to the planting.

Soil Volume. Trees respond favorably to an increase in soil volume available to their roots. The following direct relationships are apparent when studying the data collected.

- 1) Increasing the size of the actual hole dug for the root ball increases the performance of the tree and the consistency of tree health within the stand. This is especially true for the first 100 to 200 cubic feet. After this level, the data is less convincing. Exactly what is the proper planting site size, is still a subject for debate. But any planting site with less than 100 cubic feet cannot sustain long-term tree growth.

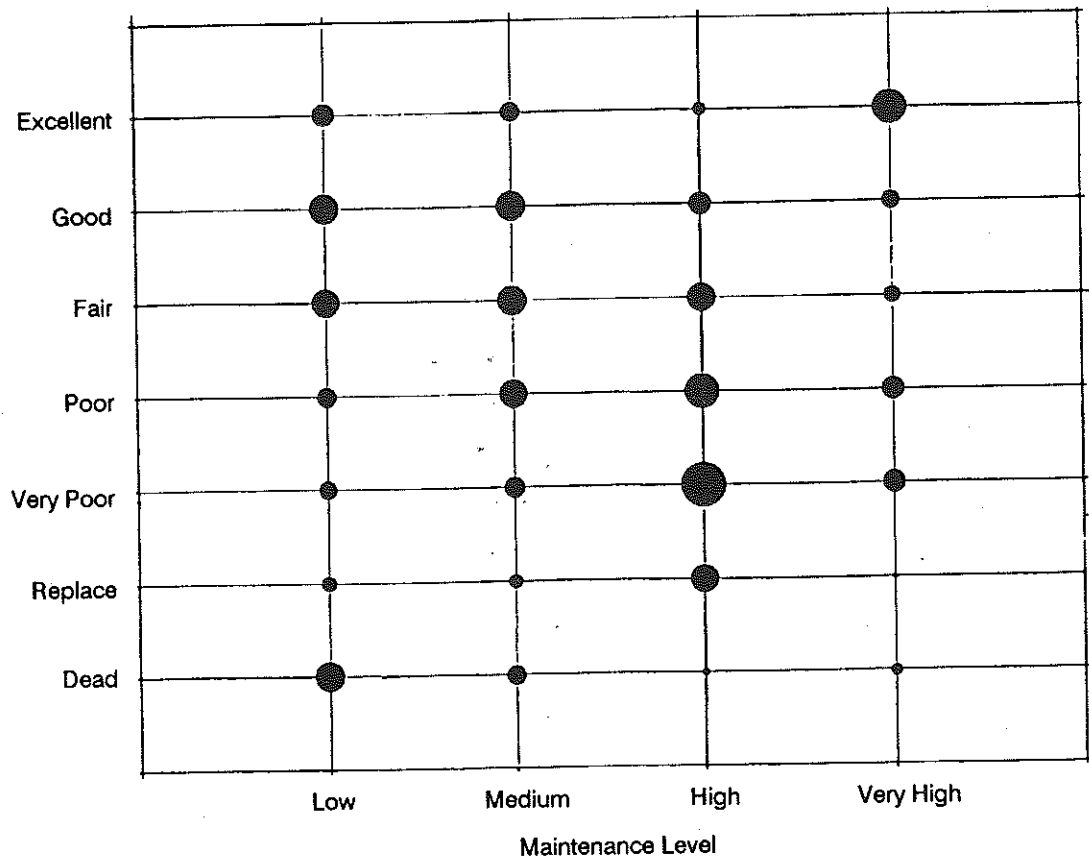
Figure 2. Tree Condition--Maintenance Level

Maintenance as a Factor in Tree Condition. In plotting maintenance levels against tree condition, no obvious relationship could be established (figure 2). It suggests that levels of maintenance are not critical in the tree's performance expectation. However, this is inconsistent with other ob-

servations. A study with tighter controls and targeted on this issue should be undertaken to resolve this conflict.

Maintenance. One of the more perplexing findings of this study was a lack of relationship between the level of maintenance and tree health. It appears that beyond simple and occasional pruning and dealing with specific insect infestations, other factors (e.g., soil and species selection) seem to outweigh maintenance. Since this finding is not consistent with other observations, it should be the subject of further research.

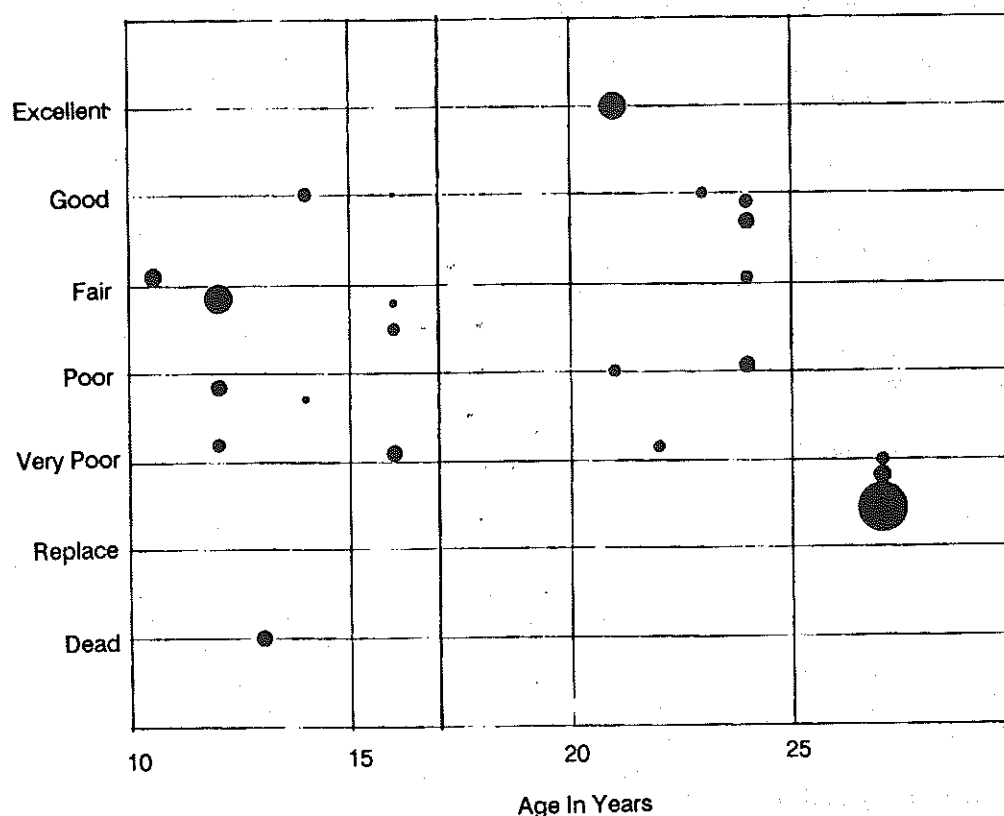
Figure 3. Tree Condition--Age

Age of the Planting. It appears that project age is not a limiting factor in tree health (figure 3). Conclusions of this study suggest that these proj-

ects are performing only slightly better than the typical urban street tree. National estimates vary from 10 to 25 years as the average life expectancy of a street tree in intensively developed urban areas. The trees at Christian Science and the trees in open planters at Constitution Plaza, however, demonstrate that age does not have to be limiting and that, after over 25 years, complete stands of healthy trees are possible.
