**Health Assessment
of the
Willow Oaks
on the
Tryon Street Mall
Charlotte NC**

**Prepared for:
Don McSween, Charlotte City Arborist**

**Prepared by:
The F.A. Bartlett Tree Expert Co.
Charlotte NC**

January 18, 2010

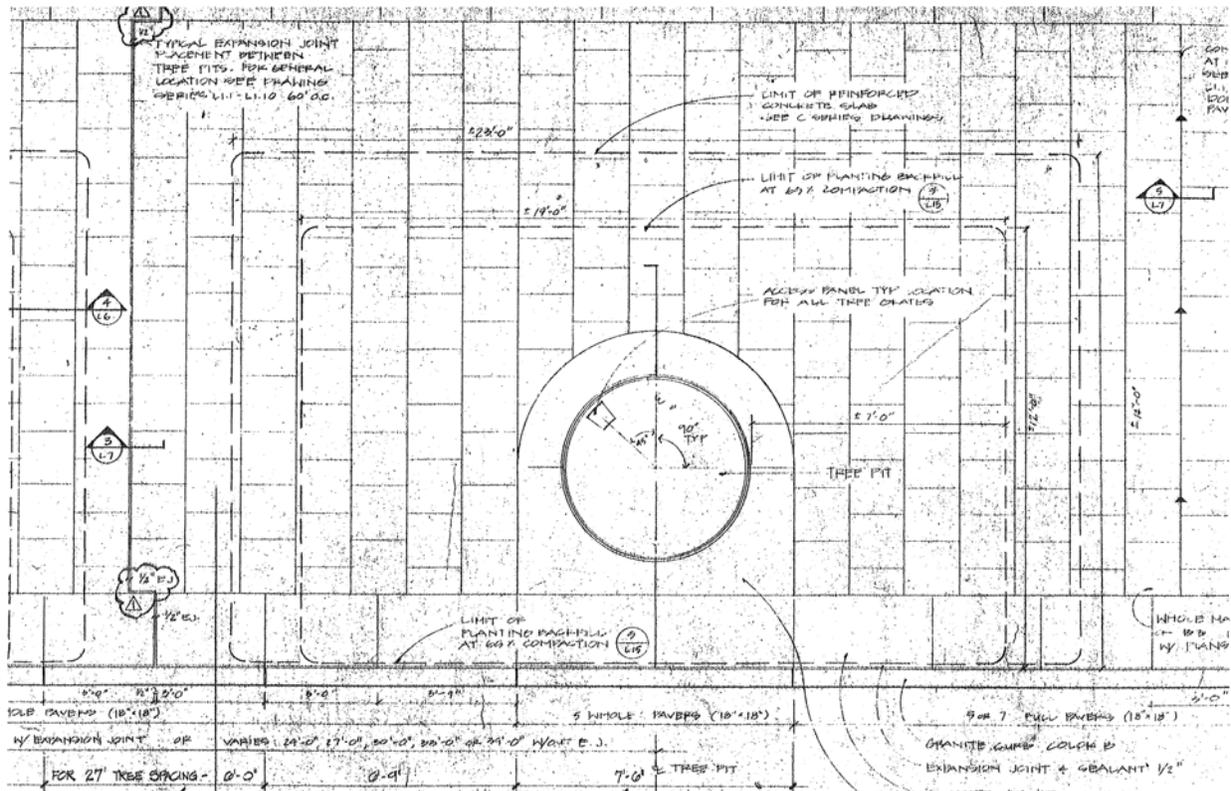
Figure 1. Copy of the Tryon Mall street tree design, top view.

The soil volume available for root growth has a direct affect the maximum size that a tree can achieve; the smaller the soil volume, the smaller the ultimate size of the tree. The soil volume available for trees in the Tryon Street Mall area is not known for sure. It is estimated from the design drawings to be 12 feet by 19 feet by 3 feet deep or 684 cubic feet.

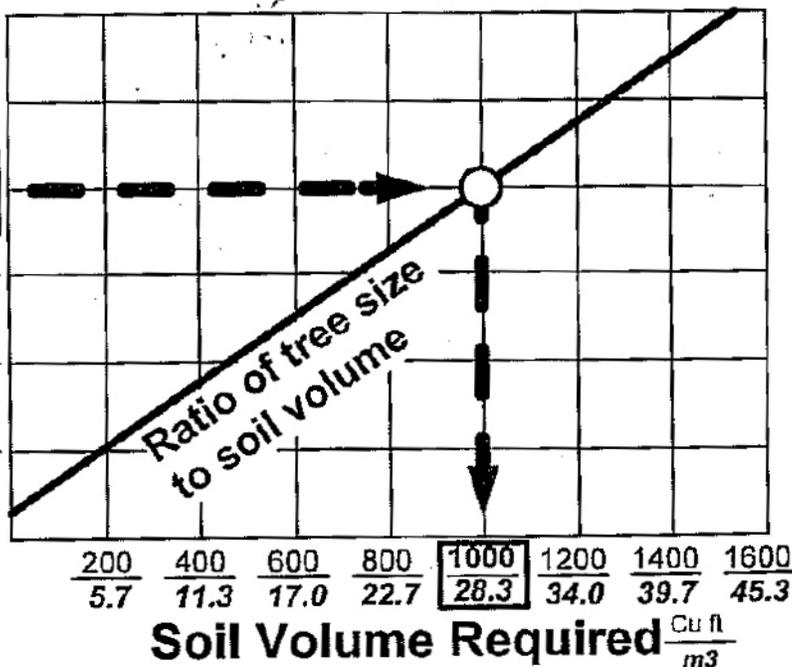
Figure 3. Tree size to soil volume comparison table from James Urban's *Up by Roots*.

Observations by James Urban and others have been used to develop tables that estimate the maximum trunk diameter and crown size based on the soil volume available (Figure 3). For example, the table shows that to achieve 16 inches in trunk diameter, a tree would require 1000 cubic feet of soil. It should be noted that these growth potential tables were developed for average tree species around the United States that have limited levels of care and may not have irrigation. Tree species and cultural practices can have a profound impact on size. Certain species are more stress tolerant than the average species, and irrigation will allow the growth of larger trees in small spaces. Willow oak is a tree that tolerates small spaces better than most species.

While the design specifications for the soil area called for 684 cubic feet, it was found that because soil depth in a majority of sites was closer two feet than three, that the actual soil volume was closer to 456 cubic feet in many sites (assuming a 12 by 19 foot horizontal space). There is also the possibility that the geotextile found six inches below grade limits rooting volume even more. Either way, the current mean tree trunk diameter of 16 inches exceeds the predicted maximum trunk diameter for the soil volume of these sites as shown in Figure 3.

Since the trees greater than 12 inches in trunk diameter are likely to have exceeded the maximum soil area, these trees should be managed to slow their growth. By managing the crown growth

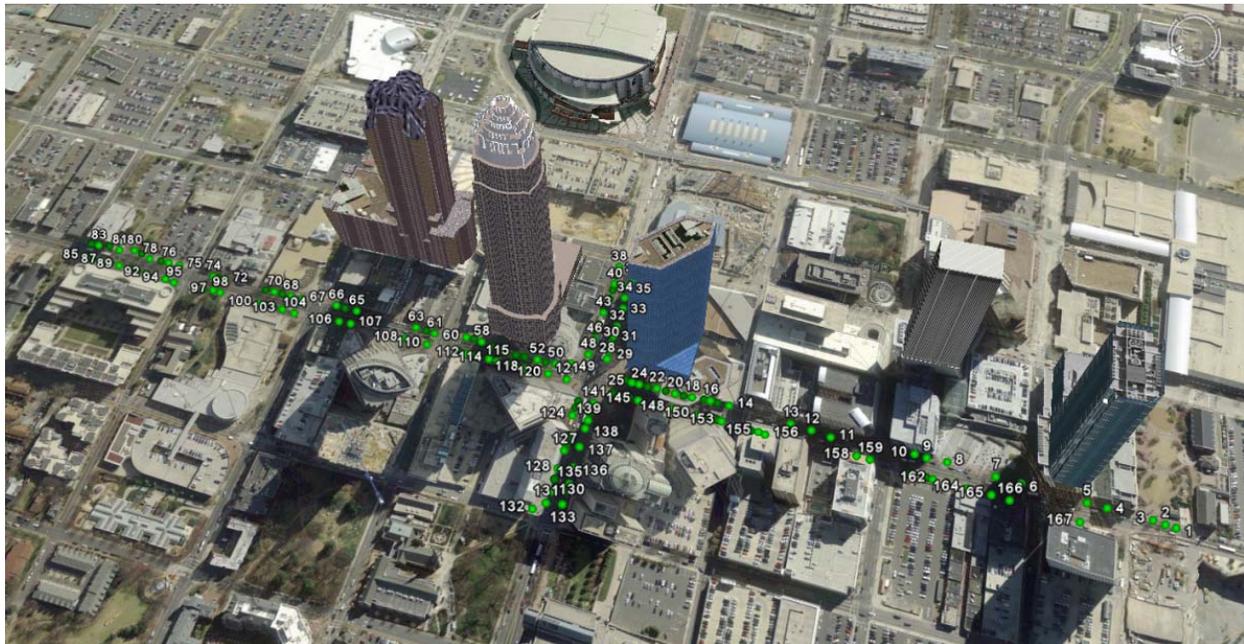
Figure 4. Tree inventory location results overlaid on Google Map view of Uptown Charlotte.

The tree inventory identified 167 willow oaks in the Tryon Street Mall study area ranging from 6 to 27 inches in diameter with an average diameter of 16.25 inches. The condition of the trees was *Good* 58% (97 trees), *Fair* 34% (57 trees) and *Poor* 8% (13 trees). Nine trees were found to be lifting the curb or pavement around the tree. The crowns of many trees were interfering with buildings, street lighting or signage. The complete inventory results are presented in a separate report included in the Appendix.

Street aspect- the difference in tree condition for those trees growing on the north side of the street was compared with the condition of the trees growing on the south side of the street. It was found that the trees in *Poor* condition were nearly evenly split between the southeast and northwest side of the street.
